# Wildlife Hazard Assessment Pompano Airpark City of Pompano Beach, FL

PREPARED FOR:  
Pompano Airpark  
City of Pompano Beach, FL  
1001 N.E. 10<sup>th</sup> Street  
Pompano Beach, FL 33060

Kimley-Horn and Associates, Inc.  
445 24<sup>th</sup> Street, Suite 200  
Vero Beach, FL 32960

Environmental Resource Solutions, Inc.  
8711 Perimeter Park Boulevard, Suite 1  
Jacksonville, FL 32216  
August 2017

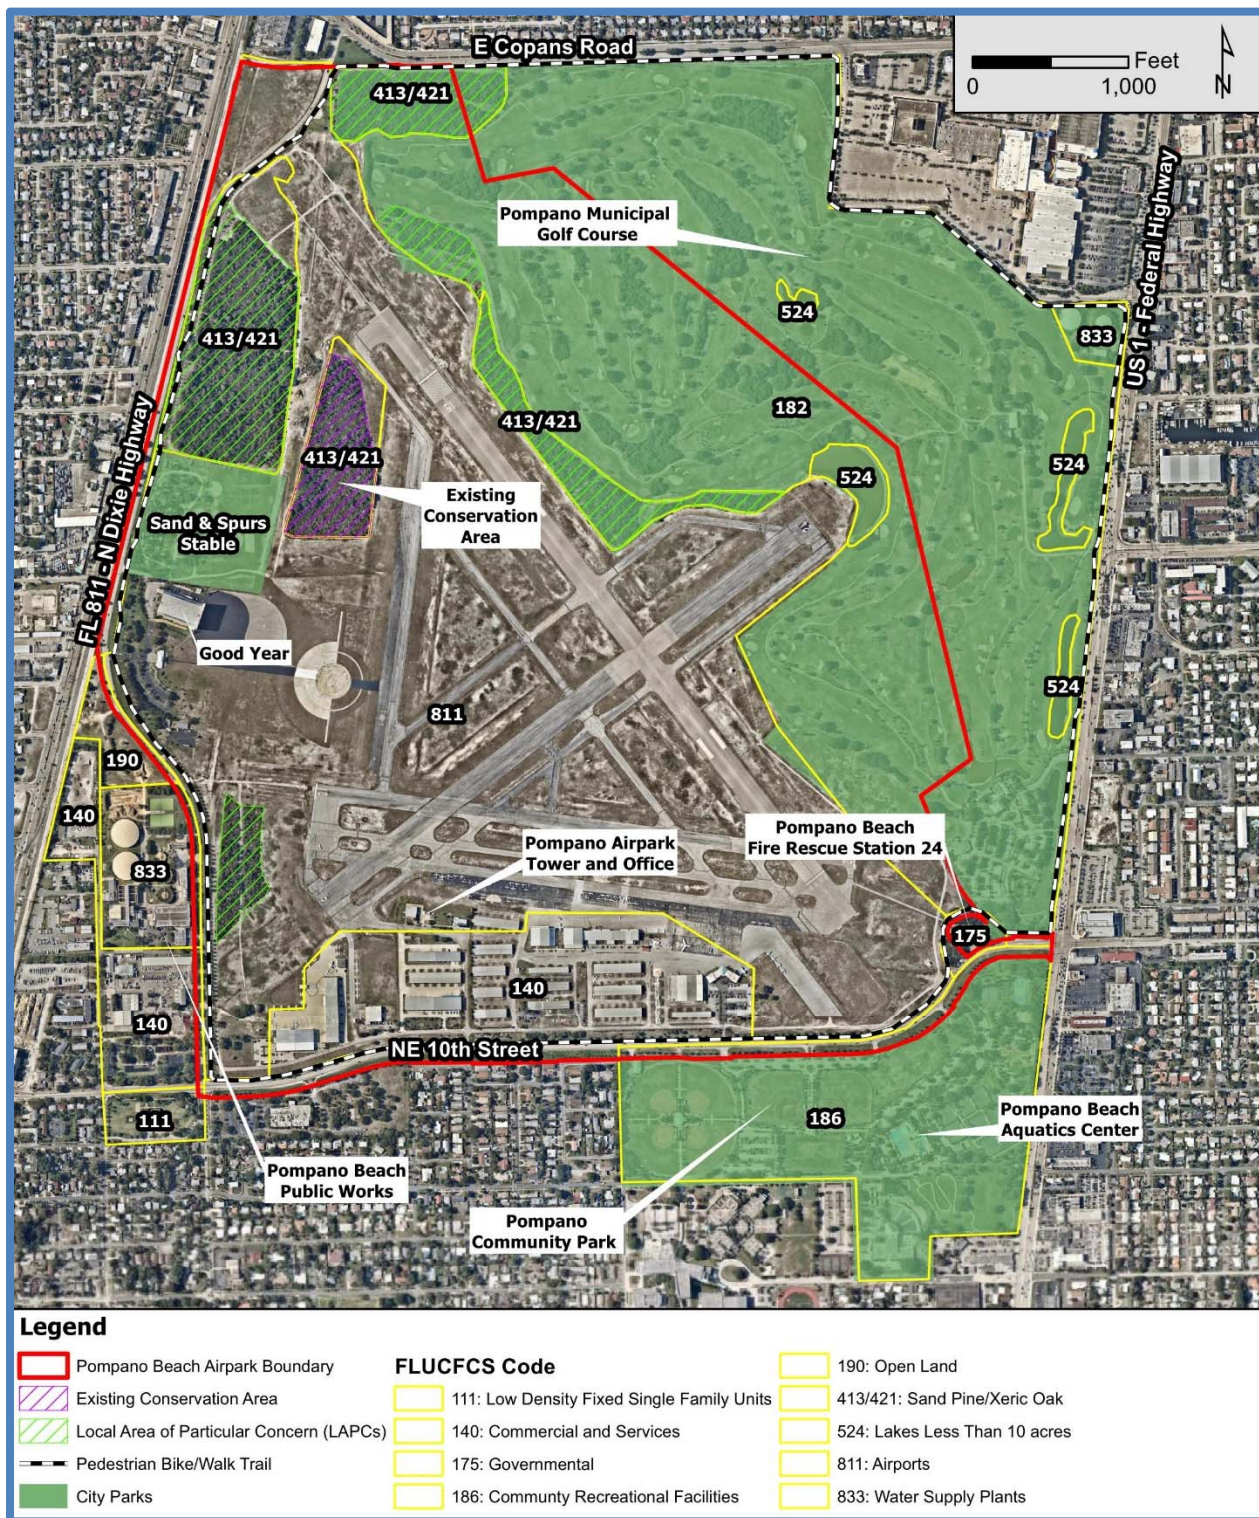
**Figure 2 Florida Land Use, Cover and Forms Classification (FLUCFCS) Map**

The four-predominant land use/cover types on airport property are described below (see **Figure 2**).

4. Wooded areas – The AOA is bordered by forested woodlands intermittently distributed throughout the airport property. These wooded areas are comprised of oak and sand pine scrub, intermixed with nuisance, exotic and landscape vegetation. As shown in Figure 2, Broward County placed a land use overlay on several of these areas and designated the areas as Local Areas of Particular Concern (LAPC). Further, the City of Pompano placed a conservation easement over one area of woodlands.

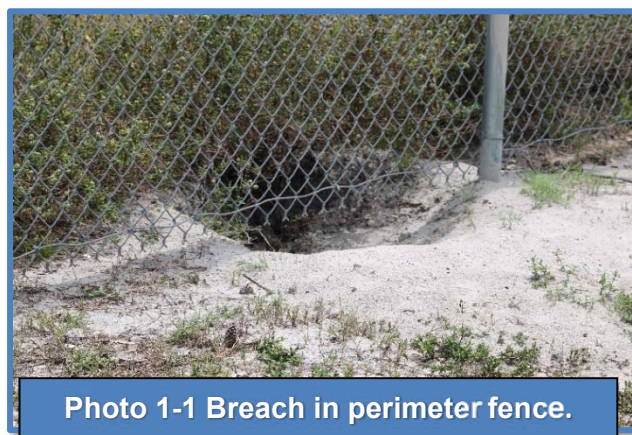
Limited wildlife hazard management has been conducted at PMP. During the study, airport maintenance staff periodically noted wildlife observed within the AOA. Maintenance staff are available during the day to respond to wildlife incidents or requests to harass wildlife away from the AOA or remove carcasses if needed. Vehicles are the primary deterrence tool utilized by PMP maintenance staff. In addition, PMP staff monitor the perimeter fence for breaches around portions of the airfield. Most the perimeter fence appeared to be intact during site inspections. One large breach was found along the fence, behind the wooded areas on the northern portion of the AOA (Photo 1-1).

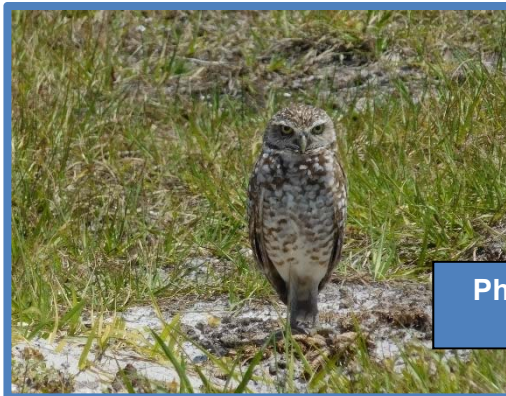
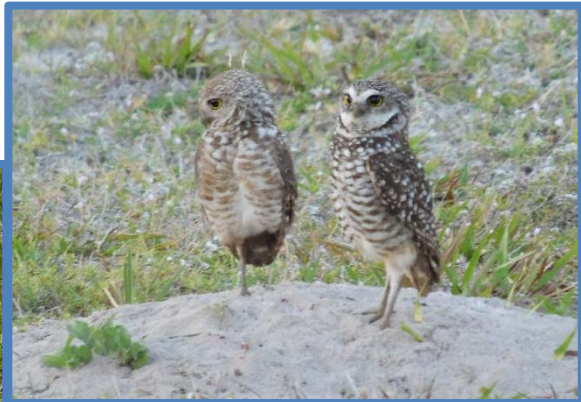
Photos 1-3 and 1-4 Burrowing owls (typ.)

Burrowing owl burrows (Photos 1-3 and 1-4) can be taken when non-active. PMP has numerous burrowing owls throughout the airport. Prior to the FWC Rule 68A-9.012, PMP obtained several permits to “take” burrowing owls for various runway and taxiway projects.

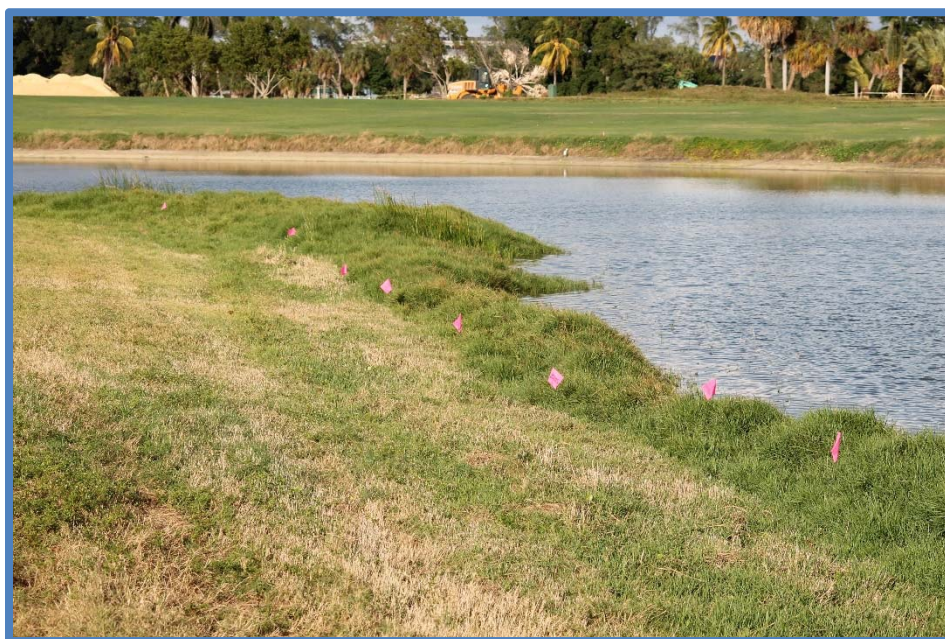
Small mammal trapping occurred twice within the 12 consecutive months of wildlife observations. One event was conducted in the winter (21 December 2016) and one event in the spring (28 April 2017) using Sherman live traps (**Photo 3-1**). Five (5) transect locations were identified (**Figure 8** is a map of the transect locations). Transect lengths varied depending on the location. For example, transects along the pond and wooded area were approximately 20 feet in length with each trap set approximately 2 feet apart while traps at the dumpster at the Sheltair facility (Transect 1) or the construction refuse area (Transect 4) were placed around the areas and not necessarily in a straight line transect. The traps were baited, set at dusk, and collected at dawn. Small-mammal data is discussed below.

Photo 3-1 Small mammal trapping transect (typ.). Traps were marked in the field with pink pin flags for easy visibility to airport employees and biologists conducting the study.

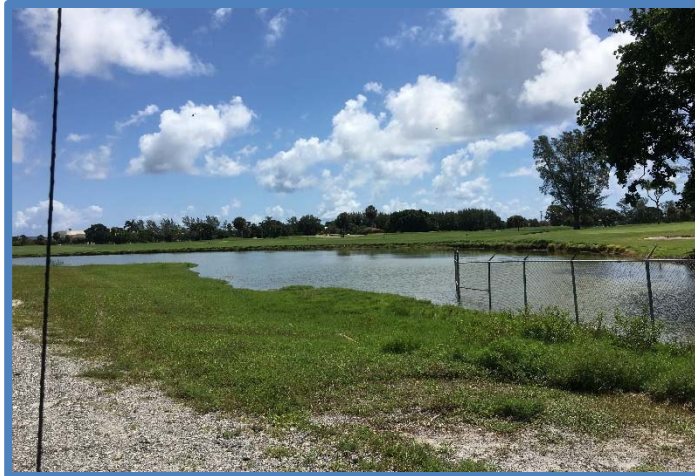
**Photo 3-2 Pond at approach to Runway 24.**

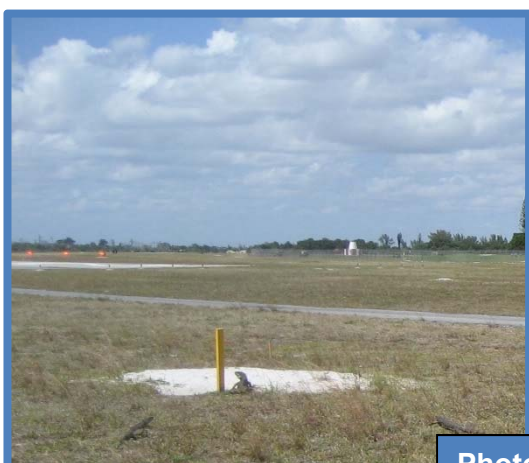
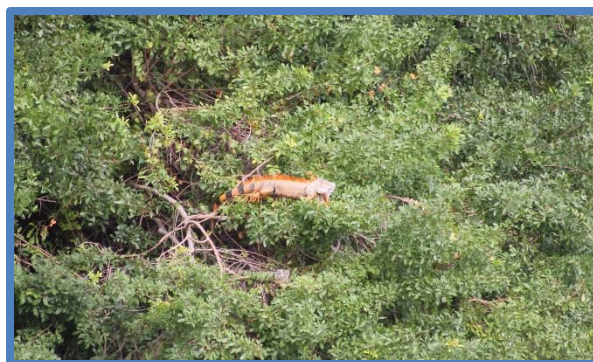
Photos 3-4 and 3-5 Iguanas (typ.)

During the 12 consecutive months of fixed-point observations, two (2) herpetofauna species, or their sign (burrows and scat), were observed and documented. **Table 9** lists the species and number of individuals observed. The FAA draft AC 150-5200-33C does not include a relative hazard score for these species. Iguanas occupy several abandoned burrows originally created by burrowing owls or gopher tortoises (**Photo 3-4**). They were documented perching in the trees (**Photo 3-5**) adjacent to the pond in grid square B4 and C4. Gopher tortoises occur throughout the airfield and were seen foraging within the AOA, crossing runways and taxiways between their burrows and foraging areas, and crossing under the fences to forage on the golf course (**Photos 3-6, 3-7, and 3-8**).

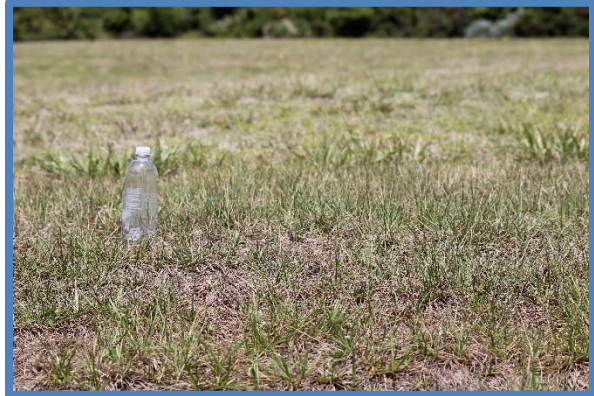
The airfield turf is maintained by mowing as needed and the majority of the airfield turf was in compliance with the FAA recommended intermediate grass height (6 to 12 inches). Some areas though have shorter (<6 inches) grass than is prescribed (**Photo 4-1**). The short grass is primarily along the ramp, taxiways, and runways. It was stated during the initial site inspection that these areas should be maintained within the FAA recommended height of 6 to 12 inches to dissuade smaller flocking birds such as mourning doves, cattle egrets, and European starlings from congregating closer to the movement areas (see **Appendix D** for a copy of the initial “WHA Site Inspection Technical Review”). These species use visual cues to communicate with each other and to alert the group if a predator is approaching or danger is nearby. Intermediate grass height disrupts or blocks the ability for these birds to visually communicate, therefore, they are less likely to flock in large numbers in these areas. The taller grass height also makes it difficult for these species to find food items (e.g. seeds, grit, and insects). A simple rule of thumb is, if you can see the eye of the bird, the grass is probably too short. Mourning doves, cattle egrets and starlings are the top 3 most hazardous species at PMP (Table 10).

**Photo 4-1 Grass/ruderal vegetation at PMP (typ.)**

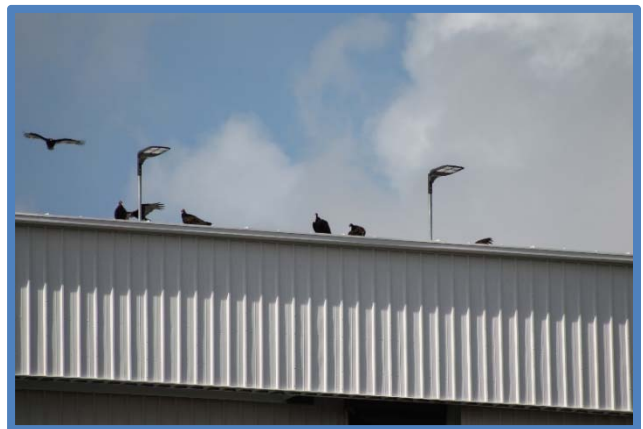
**Photo 4-2 Many turkey vultures perched on hangar at PMP.**

A variety of methods and equipment are available for excluding birds from perch sites (e.g. bird spikes, bird spiders, etc.). PMP staff should remove perching structures whenever possible (if the structure is not being used for aviation operations). When removal is not an option, deterrents should be used (**Photo 4-2**). This may require airport staff to coordinate with tenants or other government bodies (e.g. FAA) to receive permission to alter these structures.

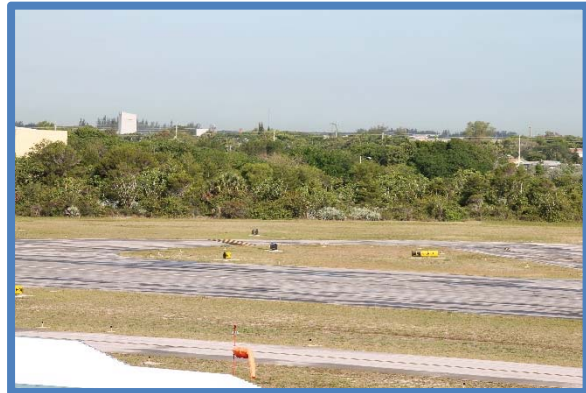
The AOA has several remnant patches of oak and sand pine scrub habitat (**Photo 4-3**) particularly in the northwest and southeast portions of the airport. These areas provide habitat for both mammals and birds. Of specific concern, the wooded areas provide shelter and direct AOA access for mammals (e.g. coyote) and perching and roosting opportunities for birds, especially raptors. Wooded areas should be removed or excluded from the AOA with secure perimeter fencing.

Photo 4-3 Remnant wooded areas (typ.).

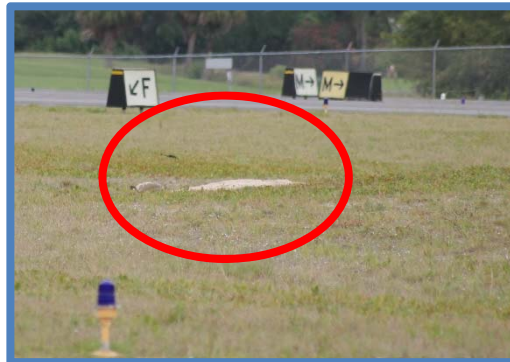
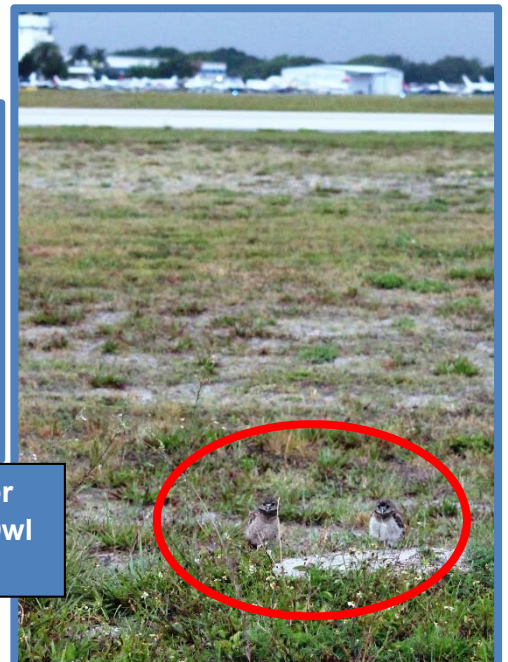
Many gopher tortoises and burrowing owls were observed throughout the AOA at PMP (Photos 4-4 and 4-5). Both species are known for the large burrows they excavate and inhabit. Additionally, iguanas have been noted in the past inhabiting the burrows and airport staff have indicated that they have seen numerous iguanas within the AOA and at burrows. Gopher tortoises can excavate large burrows, providing homes for up to 200 different commensal species. Due to their behaviors, neither the gopher tortoise nor the burrowing owl are extremely hazardous species to aviation, however, they certainly can cause a strike and may cause damage to aircraft. The greater concern comes from their burrows being near movement areas, specifically within the runway safety area. These burrows can be very large and create holes within the safety area that may damage aircraft.

Photos 4-4 and 4-5 Gopher Tortoise and Burrowing Owl Burrows

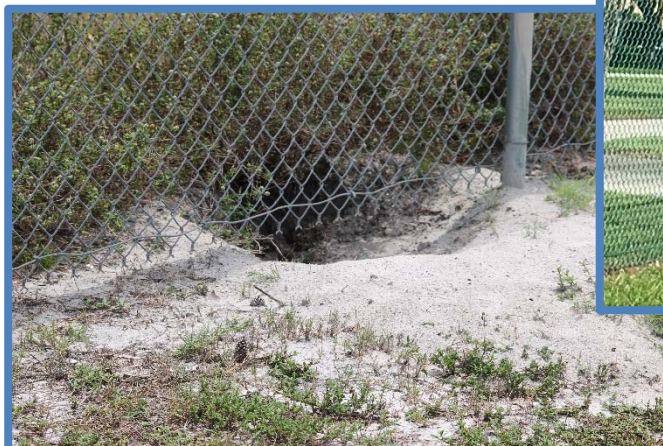
A chain-link perimeter fence completely encloses the PMP property boundary except for the stormwater pond on the golf course at the approach to Runway 24.

**Photo 4-6 Perimeter fence breach**

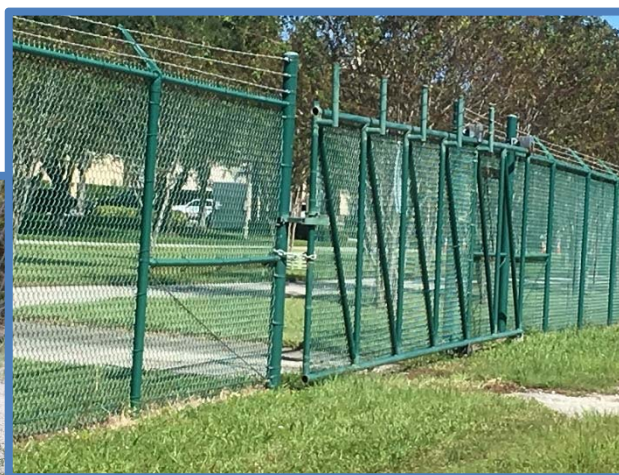
**Photo 4-7 Perimeter fence gate space greater than 6 inches**

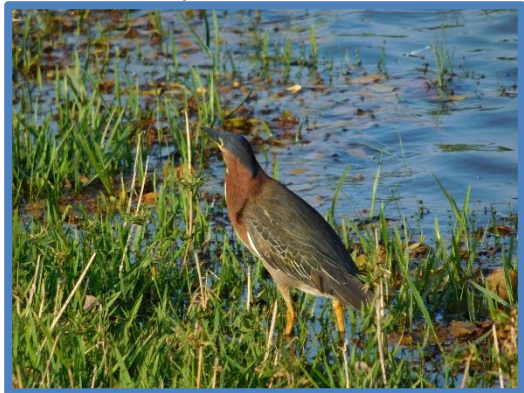
There is a large pond located directly at the approach to Runway 24 (**Photos 4-8, 4-9, 4-10 and 4-11**). The pond is within the runway safety area. During the site surveys, aquatic vegetation was observed along the pond banks, which were also very gradual. Gradual pond banks allow for a large littoral zone, attracting a variety of wildlife species. Wading birds, blackbirds, and waterfowl are all attracted to a dense littoral zone and a pond with gradual banks. To reduce the attractiveness, regular vegetation removal is recommended. Reconstructing the pond with steep side slopes would also help to reduce the attractiveness. Herons, egrets, grackles, cormorants, mallards, and least terns were all observed utilizing this pond during the study (**Photos 4-8, 4-9, 4-10 and 4-11**). The pond is the greatest wildlife attractant on the airfield at PMP.

**Photos 4-8 and 4-9 Green Heron and Double Crested Cormorants foraging/loafing on pond bank**

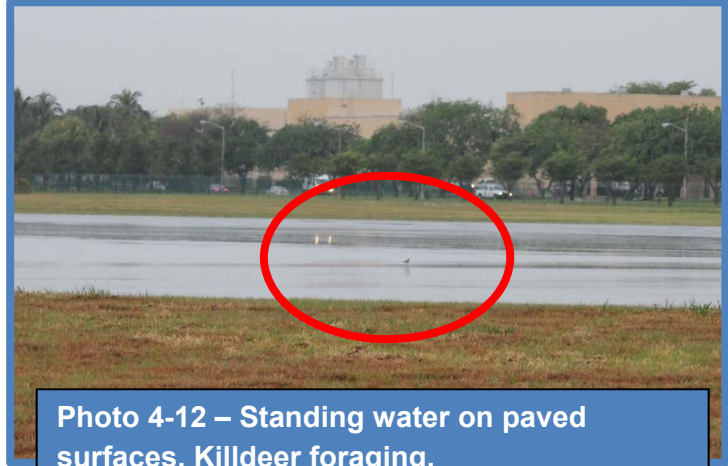
Low areas of standing water are present on paved surfaces within the AOA following a heavy rain event (**Photo 4-12**). Temporary standing water is attractive to gulls, killdeer, and other species. Killdeer were observed using these low areas of standing water to forage and loaf. These areas do drain within the FAA designated 48-hour period. PMP staff should monitor the pavement following a heavy rain event for potentially hazardous wildlife. If killdeer or other species, especially gulls, are observed utilizing the water in numbers that

**Photo 4-12 – Standing water on paved surfaces. Killdeer foraging.**

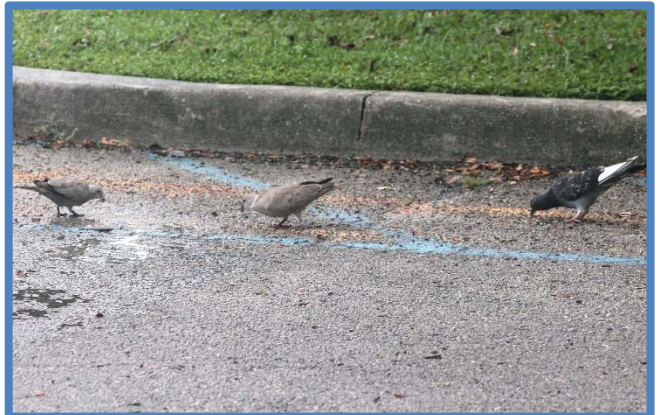
Photo 4-14 Pigeons foraging within parking lot (typ.)

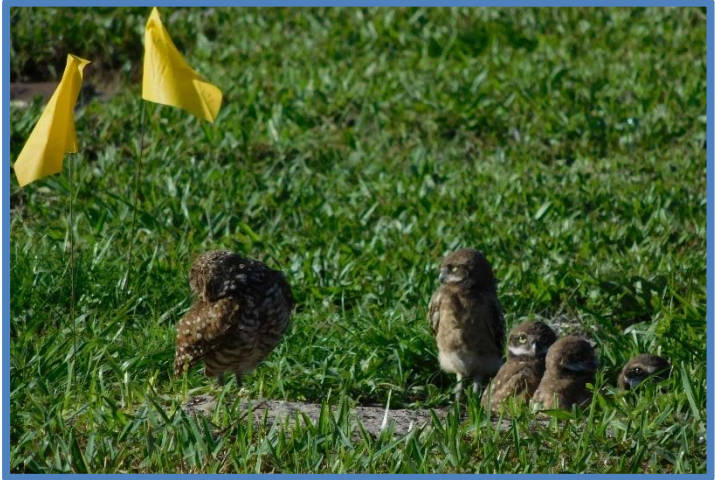
As shown on Figure 6, Forest Lawn Cemetery occurs within the 10,000-foot separation distance and observations were recorded at this location during this WHA (Monitoring Station #10). During the surveys, potentially hazardous birds were observed at the cemetery including Florida burrowing owls (**Photo 4-15**), fish crows, boat-tailed grackles and white ibis. The birds observed utilizing the cemetery did not appear to increase the risk of a strike at PMP because they were not observed crossing back and forth between the airport and the cemetery. Furthermore, Florida burrowing owls do not typically travel far from their burrow. Therefore, the Forest Lawn Cemetery was not considered a significant attractant to wildlife at PMP.

Photo 4-15 FL Burrowing owls at cemetery.

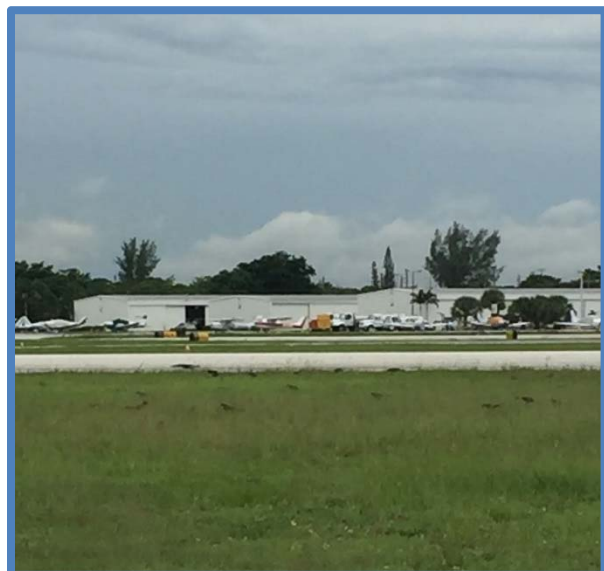
**Photo 5-1 Boat-tailed grackles foraging in ditch along taxiway at PMP.**

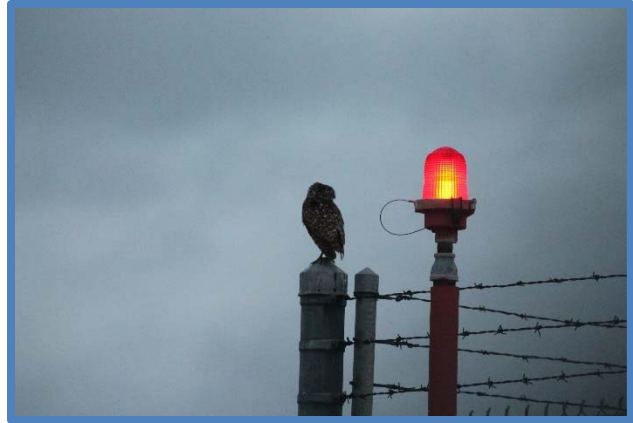
Photo 5-2 Florida Burrowing Owl perched on fence.

Control Measures: The approach to reducing raptor hazards is to make the airfield, and surrounding airspace, unattractive by eliminating perching/nesting opportunities and food sources. Most raptors will perch on a snag or large, isolated tree before attacking their prey. On airports, they will also use man-made structures such as fencing, weather antennas, windsocks, and lighting systems (**Photo 5-2**). Adding perching deterrents, such as bird spiders, to man-made structures or eliminating any unused structures and snags can reduce perching opportunities.

Small mammals (rodents) were not observed during trapping events, but the presence of hawks and other raptors make it reasonable to assume that small mammals do occur on the AOA at PMP (see *Section 3.3.2 Small-mammals* for details). Reducing small mammal populations on the AOA will reduce the birds' primary food source. Removing wood areas within the airport could also help reduce the kestrel and hawk populations. Typically, lethal control is not recommended

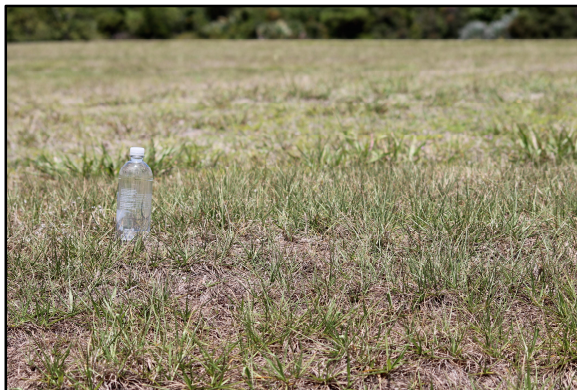
The majority of the airfield turf was in compliance with the FAA recommended intermediate grass height (6 to 12 inches). However, some areas were noted as having shorter (< 6 inches) grass than is prescribed. **Photo 1** is a picture of the mowed areas in the AOA that were shorter than the FAA guidance. These areas are mainly along the taxiways and runways. It is recommended that the grass be maintained within the intermediate height range (6 to 12 inches) to dissuade smaller flocking birds such as doves and European starlings from using this area. A general rule of thumb is that the grass should be tall enough to cover the starling's eye. This limits the bird's predator detection and makes them feel unsafe. Therefore, they choose a different (and safer) place to forage.

**Photo 1. Short grass within the AOA at PMP**

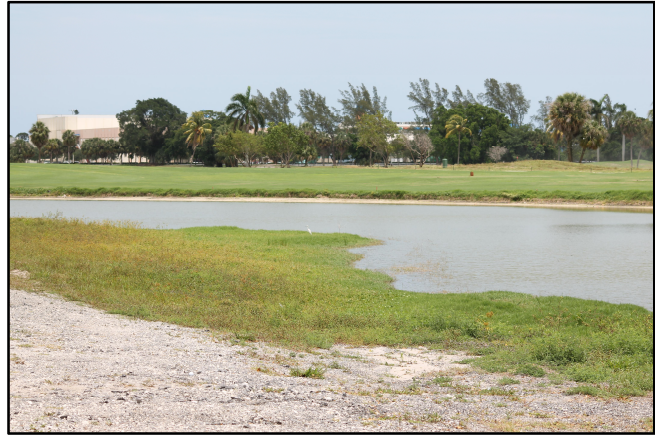
**Photo 2. Stormwater pond at approach to Runway 24 at PMP.**

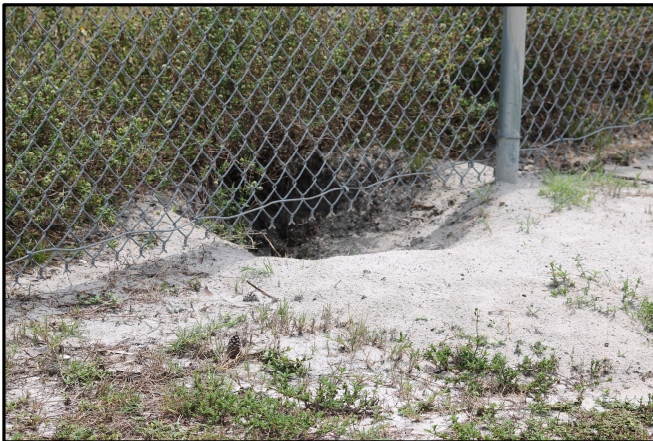
**Photo 3. Breach in perimeter fence at PMP.**

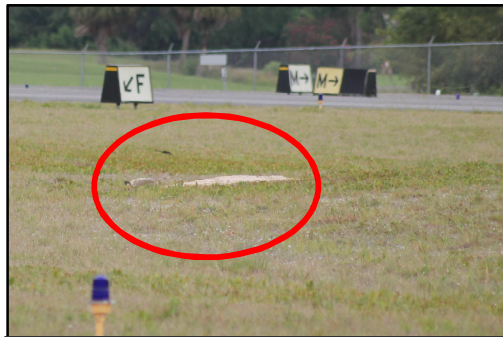
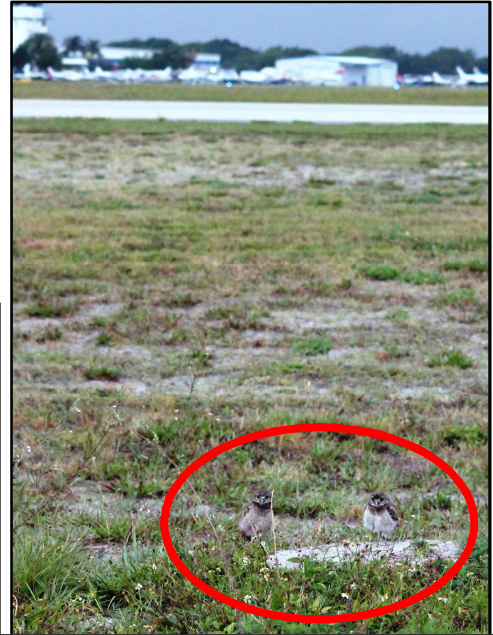
Photo 4, left. Gopher tortoise just outside it's burrow on the AOA at PMP. Photo 5, right. Two burrowing owl fledglings outside their burrow on the AOA at PMP.

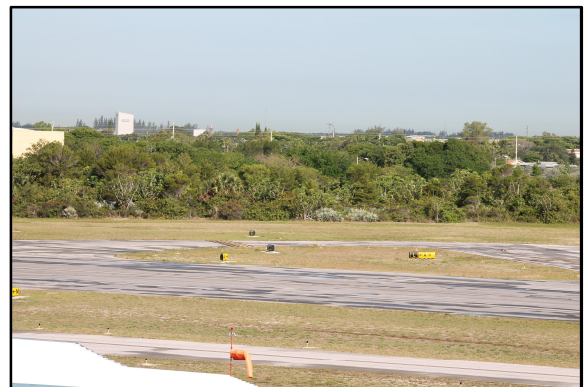
Photo 6. Wooded areas inside the perimeter fence at PMP.

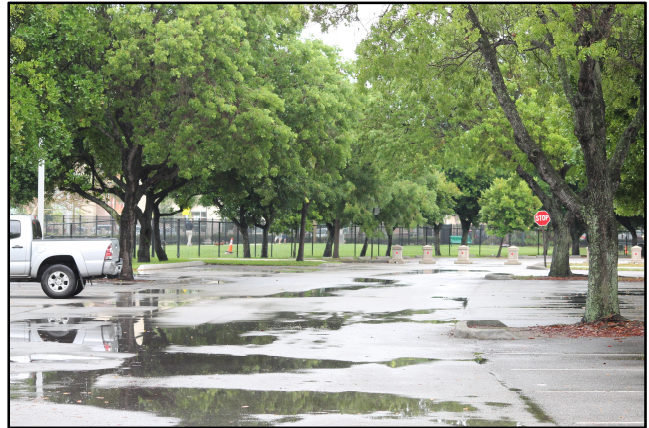
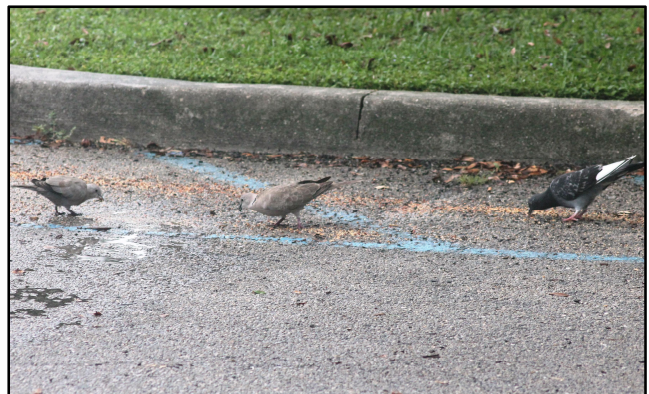
Photo 7, top. Large trees lining the parking lot along the golf shop, golf course restaurant, and dog park.  
 Photo 8, bottom. Bird seed in parking lot at Pompano Community Park, just south of PMP.
