**Subject: Accidental Wastewater Discharge Comment Response Letter
Break of 42" Sewer Force Main at NW 15th Street and I-95
Pompano Beach, FL**

Figure 1: Site Location Map

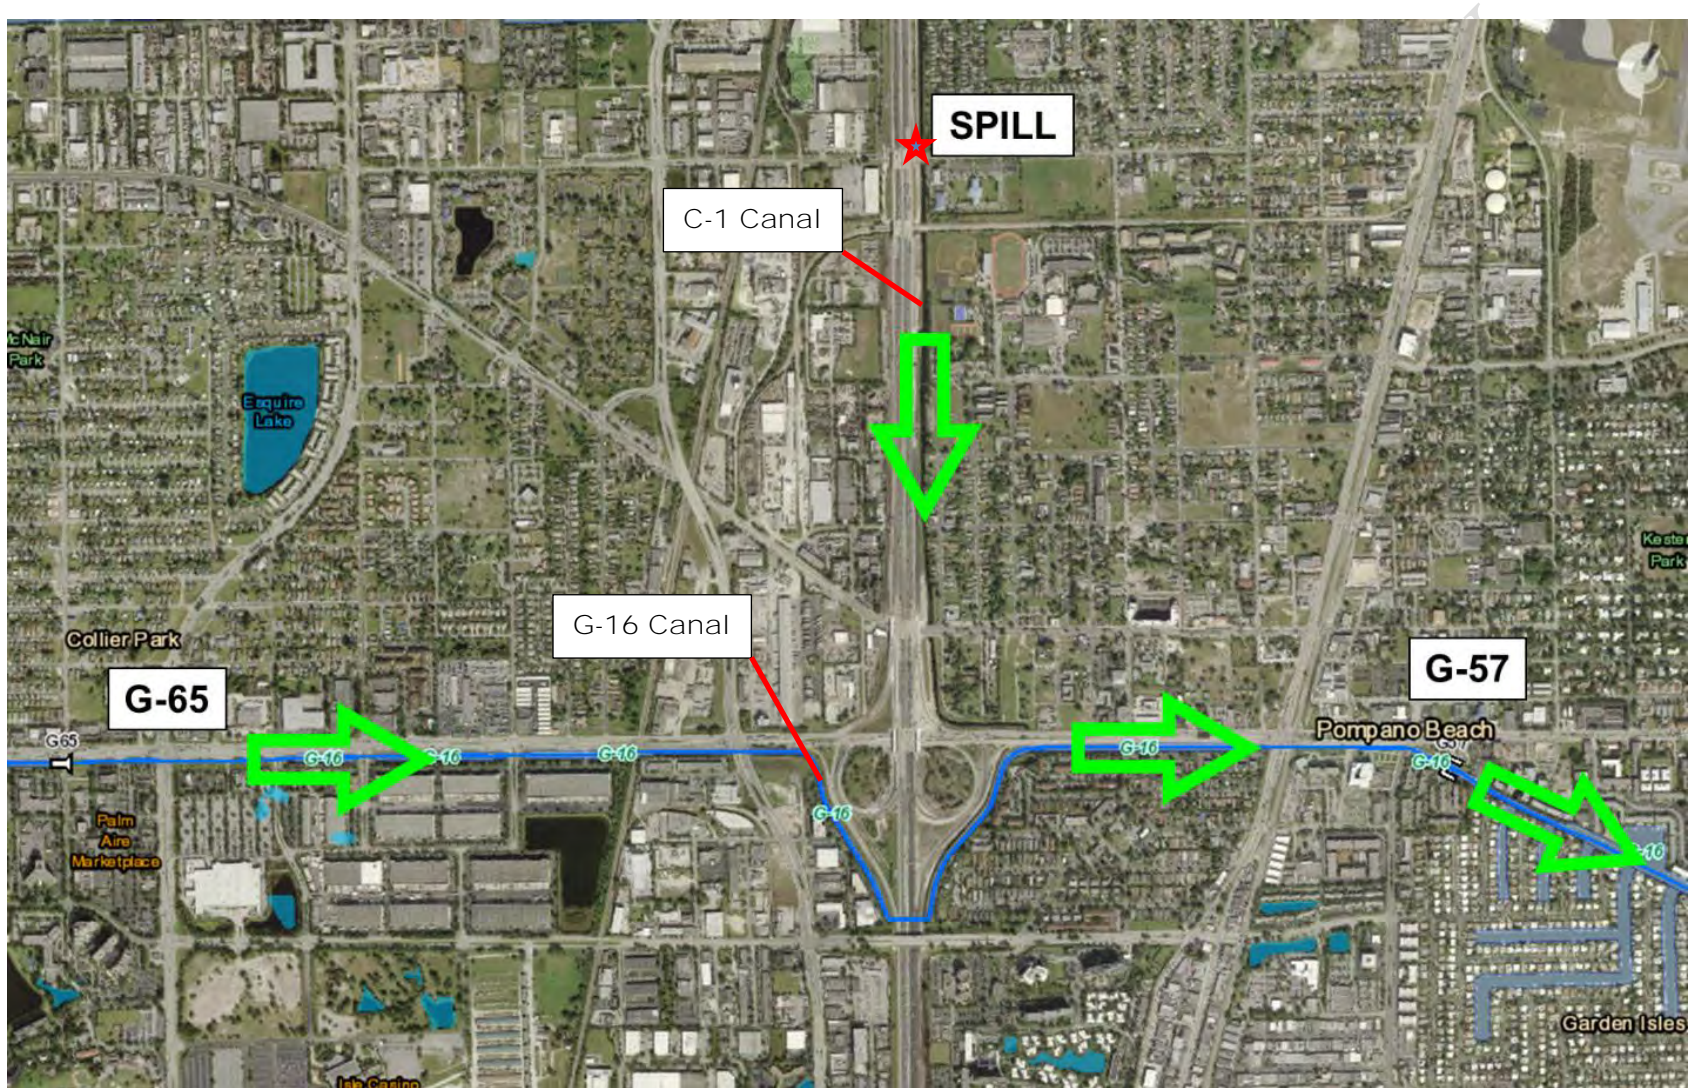
On the afternoon of Friday January 4, 2019, a construction accident caused by a subcontractor working for the Florida Department of Transportation (FDOT) ruptured a 42" pressurized sewage pipe which spilled untreated sewage into the drainage canal system from north of NW 15 Street. The wastewater flowed into the C-1 Canal, traveled south and entered the G-16 canal (Pompano Canal) where it headed east toward the G-57 Gate and finger canal that lead to the Intracoastal Waterway. See Site Location Map provided as **Figure 1** and the location of core samples are in **Figure 2**.

1. Figure 1 of the plan identifies all canals and waterways impacted by the sewage spill. Please advise of any revisions to this figure since January 31, 2019.

Based on APTIM's evaluation of the available surface water data collected to date, no revisions are recommended to **Figure 1** Estimated Maximum Extent of Fecal Indicator Bacteria in Surface Water, provided to BCEPD on January 31, 2019.

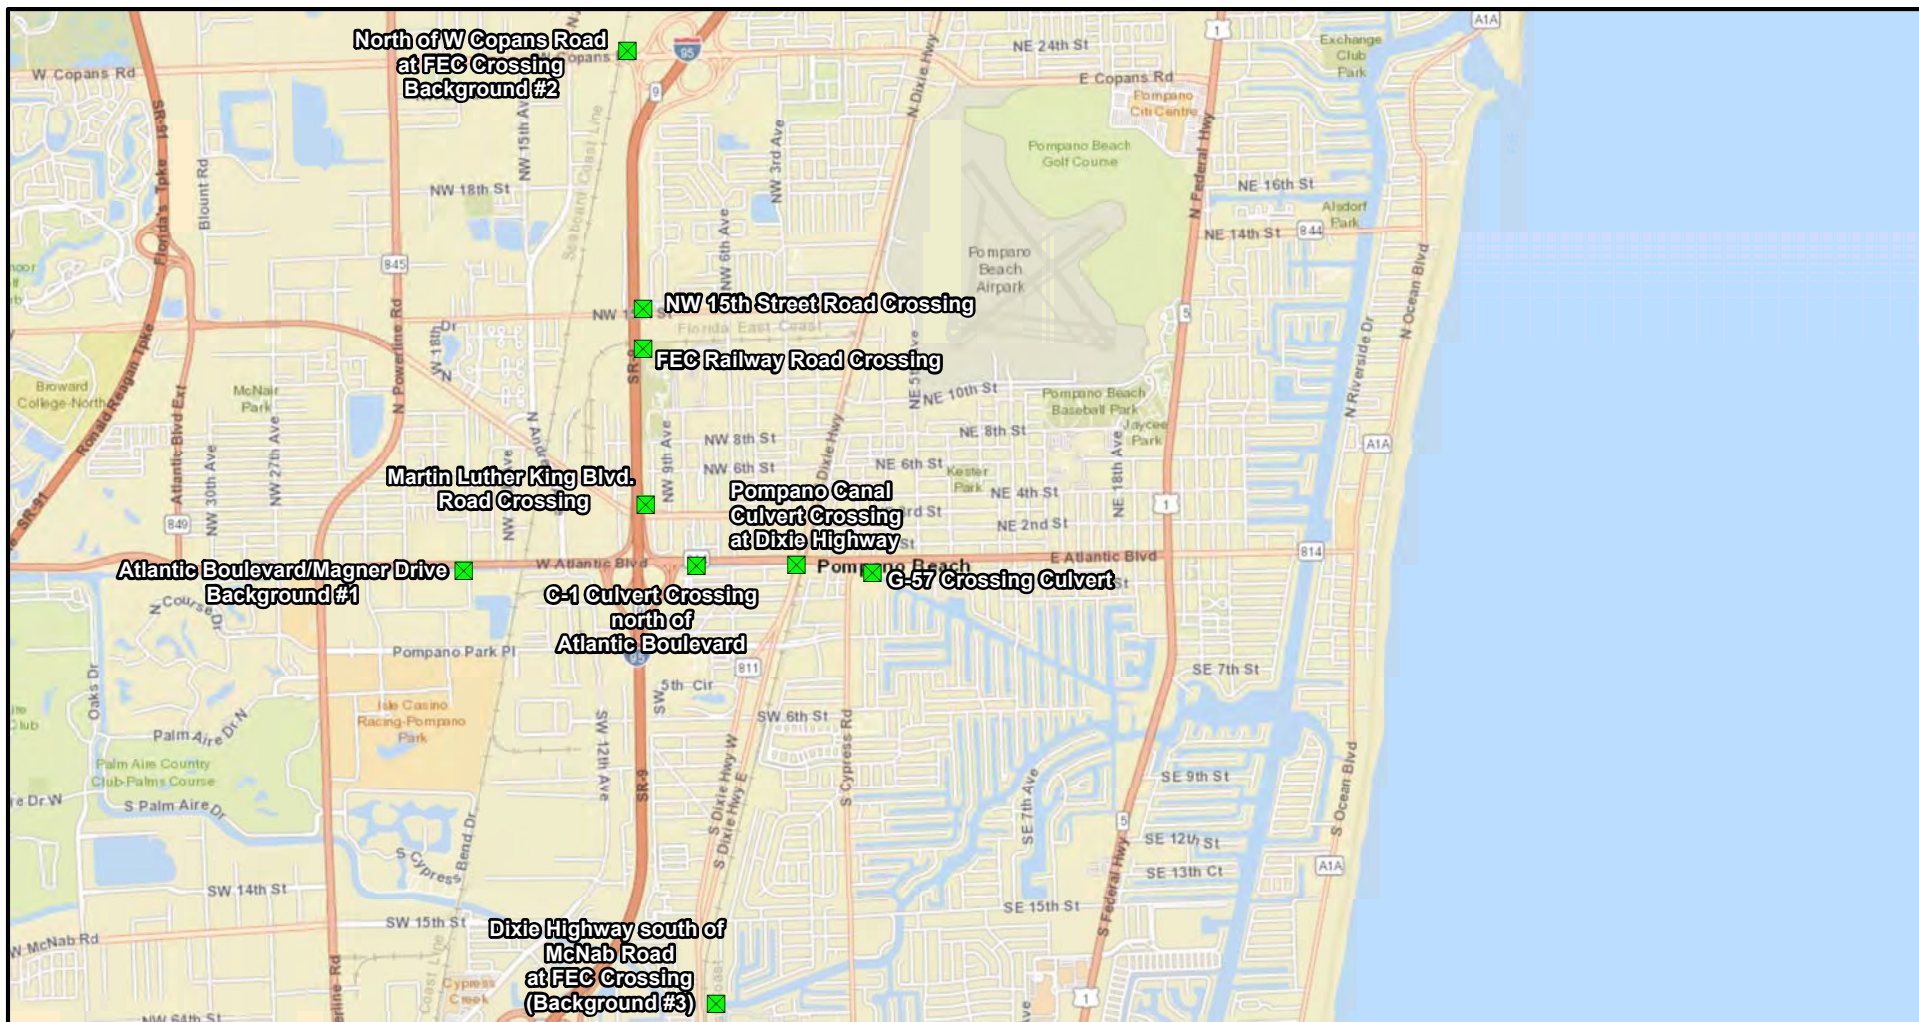
Legend:

- Flood Gate or Culvert (Sediment Sampling Location)

A total of nine (9) sampling locations were selected for the initial sediment sample collection event. A total of fifty-three (53) sediment samples were collected for screening at the following locations: NW 15th Street Road Crossing, FEC Railway Road Crossing, Martin Luther King (MLK) Blvd. Road Crossing, C- 1 Culvert Crossing north of Atlantic Boulevard, Pompano Canal Culvert Crossing at Dixie Highway, G-57 Crossing Culvert, Atlantic Boulevard/Magner Drive (Background #1), North of W Copans Road at FEC Crossing (Background #2), and Dixie Highway south of McNab Road at FEC Crossing (Background #3). The Sediment Sampling Locations (Gate/Culverts) are illustrated on **Figure 2**.

After the sediment collection method had been tested and confirmed, APTIM collected sediment core samples in the C-1 Canal and Pompano Canal. Sediment samples were collected at measured step-outs, across the canal, at six (6) separate upstream headwalls of gates and culverts located in C-1 Canal and Pompano Canal and three (3) additional locations were collected outside of the area of impact to represent background conditions. The locations of the C-1 Canal, Pompano Canal (G-16), and the flood gates & culverts are illustrated on **Figures 1 and 2**, respectively.

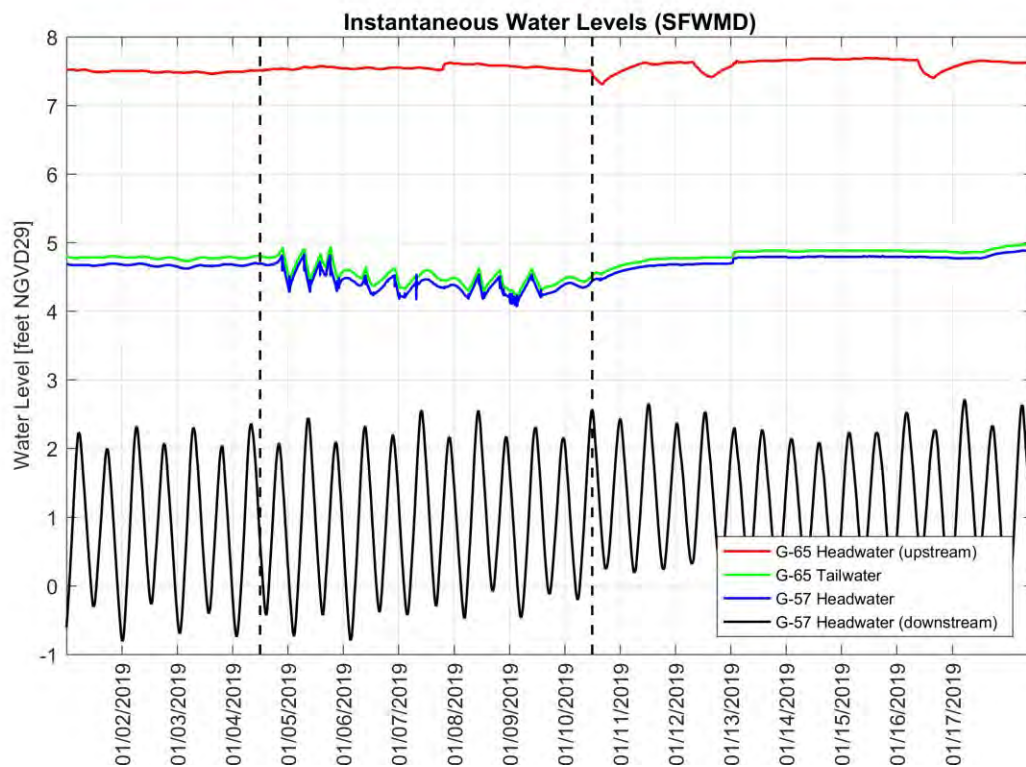
Figure 3: Pompano Canal Discharge data before, during and after the wastewater spill (SFWM).

This section describes hydraulic measurements (including water flow rates and water levels) taken by the South Florida Water Management District (SFWMD) at two gated flow control structures located along the Pompano Canal G-65, and G-57. G-57 is downstream of the spill location after C-1 canal intersects the Pompano canal. G-65 is upstream of G-57 and supplied additional water to the G-16 canal that could mobilize the sewage.

There was little rainfall all January until Jan 21. The only non-zero rain volume record at G-57 station indicates 0.07 inches on January 13. The lack of rain allows for an easy estimation of the extra flow through the canal due to the spill. The G-57 and G-65 discharge data before and after the spill are shown in **Figure 3** and **Table 1**. Daily G-57 flows are in **Table 2**. The “-14.1” flow (cfs) in **Table 1** is the average extra flow mainly due to the sewage release. A flow of 14.1 cfs for six days is approximately 52 M gallon, which is consistent with the estimated total volume of sewage released. As seen from **Table 2** and **Figure 3**, gates G-65 and G-57 were closed on Jan 8 and 11, respectively, thus isolating the wastewater cumulated between the locks and along the C-1 canal allowing for more solids to collect on the water surface or to settle to the bottom of the canal. The “After Spill” values in **Table 1** are zero since both gates were closed. The G-57 water flow was relatively constant except for the few days after the spill (**Figure 3**). The water levels at G-65 and G-57 stayed relatively constant except for small variations after the spill (**Figure 4**). Water levels after G-57 (**Figure 4**) were variable, which may have resulted from tidal influence and intermediate gate opening/closure in response to the spill flow, water level rise upstream the

lock, and water quality concerns to adjacent waterbodies. In addition to gated structures (G-65 and G-57), water flow in C-1 is limited by berms containing bottom culverts at the FEC Railway Road crossing and at Martin Luther King Blvd crossing. These berms will tend to collect floating solid materials behind them. **Figure 5** shows the discharge flows and daily rainfall amounts over a more extended time. The calculated mean discharge flow (sum of flow from G-65, normal C-1 flows and from the spill) through the G-57 gate during the spill was in the order of 30 cfs.

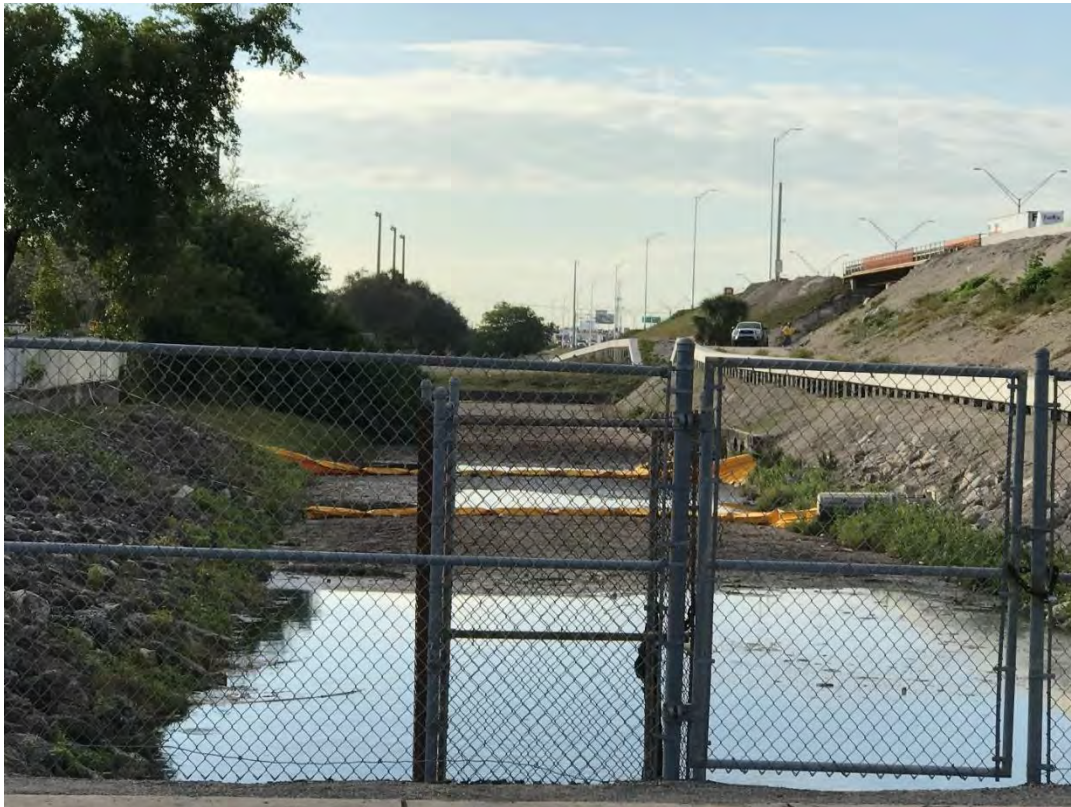
Figure 5: Rain and discharge measurements at Pompano Canal (SFWM).

Relatively high rainfall volumes were observed in the last week of January and the first week of February. (See **Figure 5**.) Surrounding surface water entered the canals resulting in canal water level rise and sporadic G-57 gate openings and discharge through G-57. On February 11, the G-65 gate was opened, releasing approximately 40 cfs into the canal section west of G-57. This has led to more constant flow rates through G-57, which on average exceeded 50 cfs between February 11 and 25. The cumulative flow volume through G-57 within the weeks following the spill (up to February 25) is in the order of 750 M Gallons of water – 15 times the amount wastewater volume spilled from January 4-10.

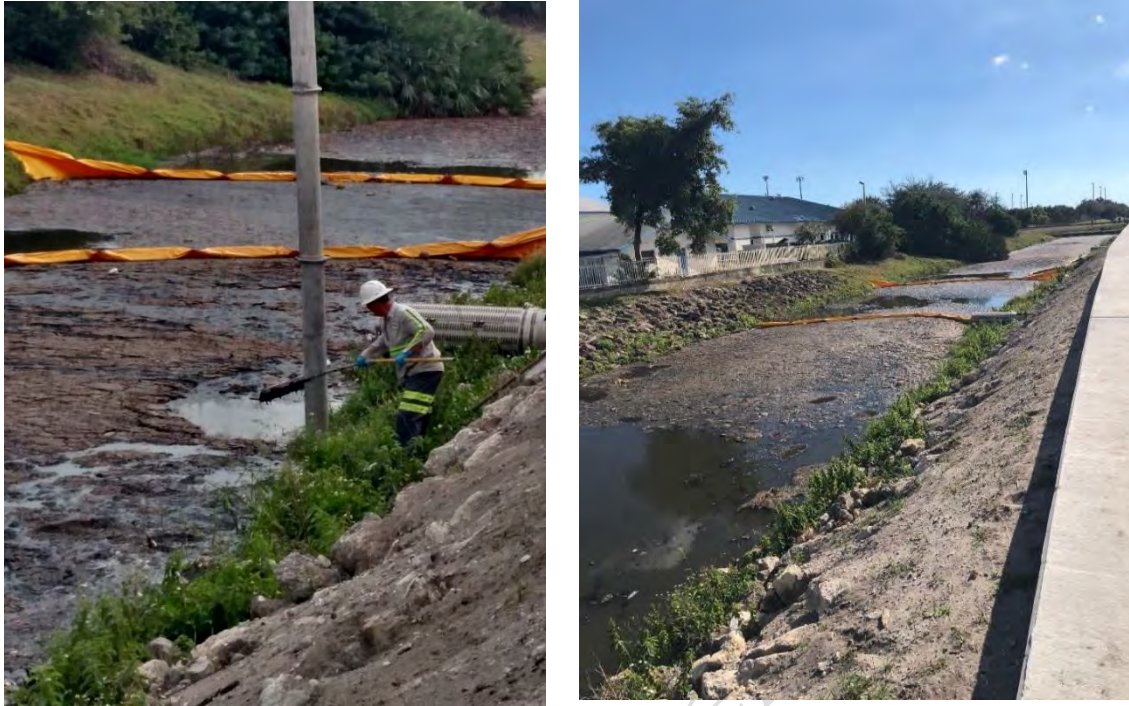
Figure 6: Floating material removed accumulated by the floating turbidity curtains and removed from site.

On the days following the force main rupture, the contractor Lanzo removed canal liquids with floating solids from the channel section between 15th St and FEC Railway crossing. The effort included four (4) trucks (15 cubic yards) making 15 loads per day, totalizing between 750 and 900 cubic yards of material transferred each day during a 7-days period. The total amount of material removed by Lanzo is estimated to be 5,775 cubic yards.
